Wind Farm CASALDUNI

Inspector	Ing. Matteo Canevello
Attendants to the inspection	Ing. Raffaele Petrucciolo
Inspection Date	04.05.2023

Site Visit Report Wind Farm CASALDUNI

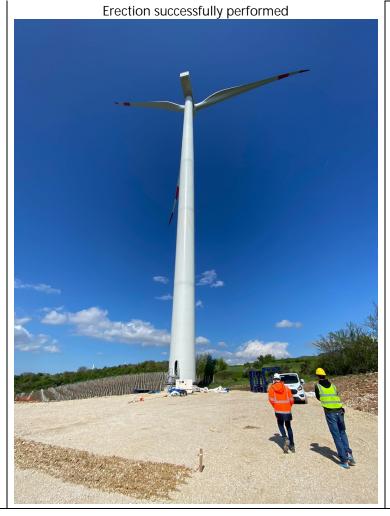
6.3

No relevant defect raised during the inspection

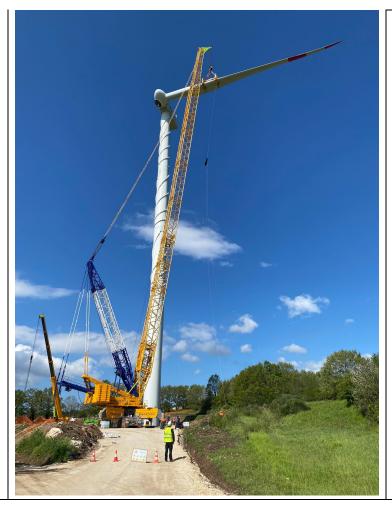
7	WTG11		
7.1	Crane platform	Works completed, restoration works to be done after the WTG erection completion	No relevant defect raised during the inspection
7.2	Foundation	Foundation piles successfully tested and backfill completed, waiting for the WTG erection	No relevant defect raised during the inspection
7.3	WTG	Works ongoing	No relevant defect raised during the inspection

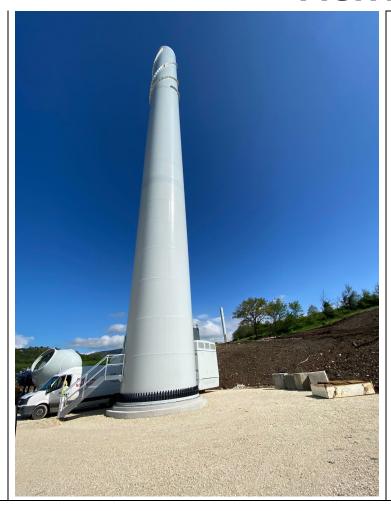
8	WTG13		
8.1	Crane platform	Works completed, restoration works to be done after the WTG erection completion	No relevant defect raised during the inspection
8.2	Foundation	backfill works completed	No relevant defect raised during the inspection
8.3	WTG	Works ongoing	No relevant defect raised during the inspection

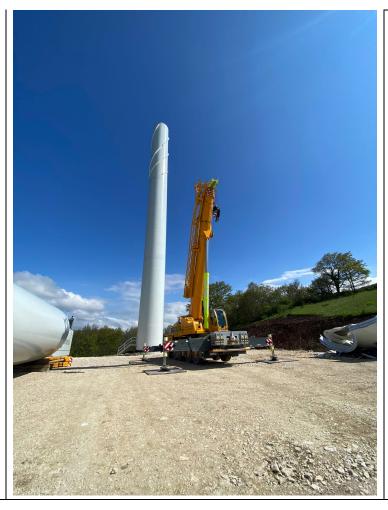
9	WTG14		
9.1	Crane platform	Works completed, restoration works to be done after the WTG erection completion	No relevant defect raised during the inspection
9.2	Foundation	backfill works completed	No relevant defect raised during the inspection
9.3	WTG	Works ongoing	No relevant defect raised during the inspection

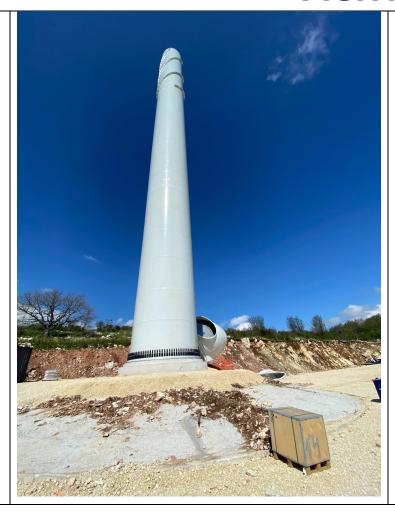
10	WTG18		
10.1	Crane platform	Works completed, restoration works to be done after the WTG erection completion	No relevant defect raised during the inspection
10.2	Foundation	backfill works almost completed	No relevant defect raised during the inspection
10.3	WTG	Works ongoing	No relevant defect raised during the inspection

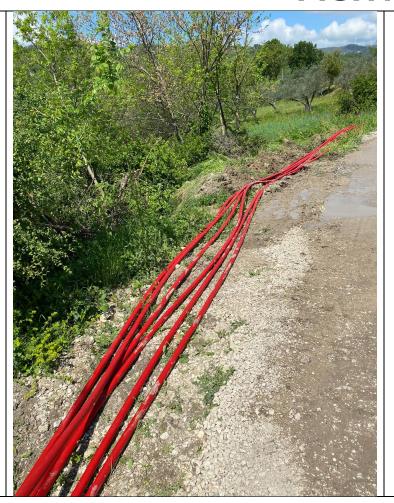
14	Underground MV line		
14.1	Trenches and cable laying	Works ongoing, the delivery of the cable will be done time to time the work progress	No relevant defect raised during the inspection

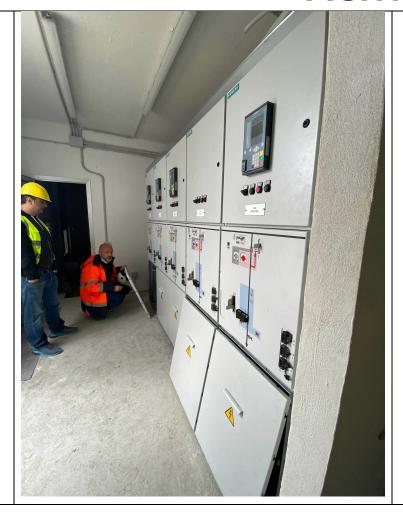
15	Electrical Substation		
15.1	Civil works	Minor civil works expected to be completed soon	No relevant defect raised during the inspection
15.2	Cabins	Switchgears expected delivered and installed	No relevant defect raised during the inspection
