Wind Farm CASALDUNI

Inspector	Ing. Matteo Canevello
Attendants to the inspection	Ing. Raffaele Petrucciolo
Inspection Date	05.04.23

Site Visit Report Wind Farm CASALDUNI

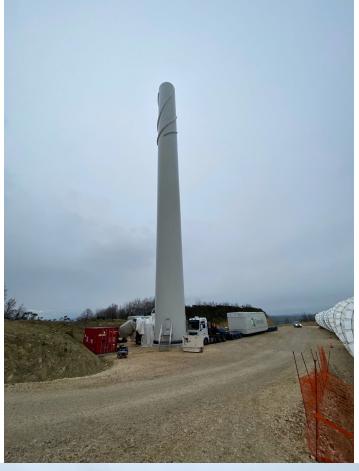
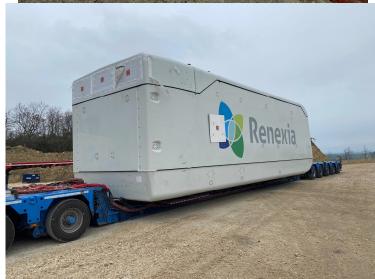
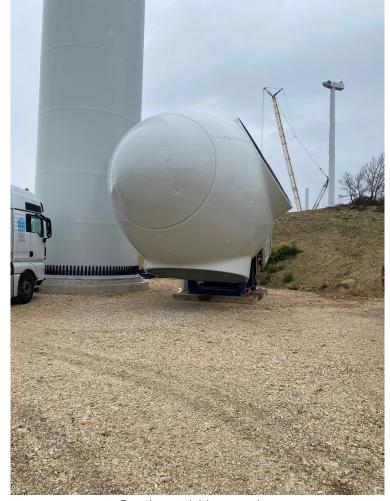
4 WTG

No relevant defect observed during the inspection

Erection activities ongoing

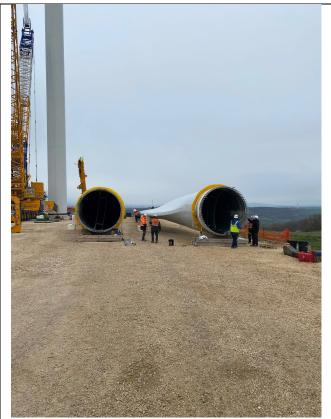
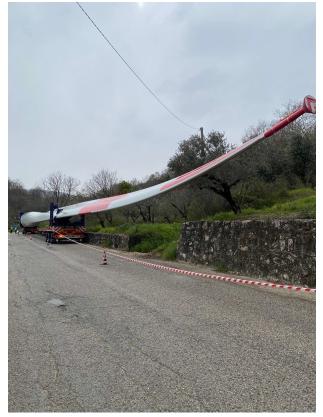
Blades installation

Erection activities ongoing

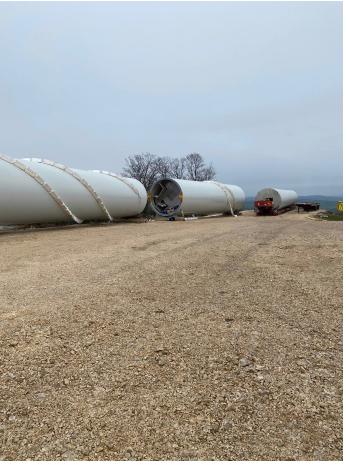
8.3 WTG

No relevant defect observed during the inspection

Erection expected in the next days

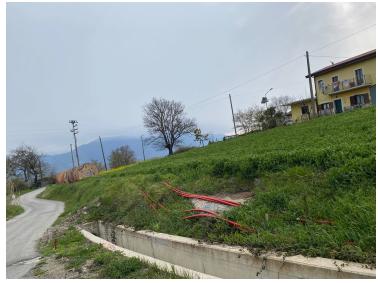
13.4 Trenches and cable laying

No relevant defect observed during the inspection

Works ongoing, the delivery of the cable will follow the work progress
