## Wind Farm CASALDUNI

Inspector	Ing. Matteo Canevello
Attendants to the inspection	Ing. Raffaele Petrucciolo
Inspection Date	13.07.2023

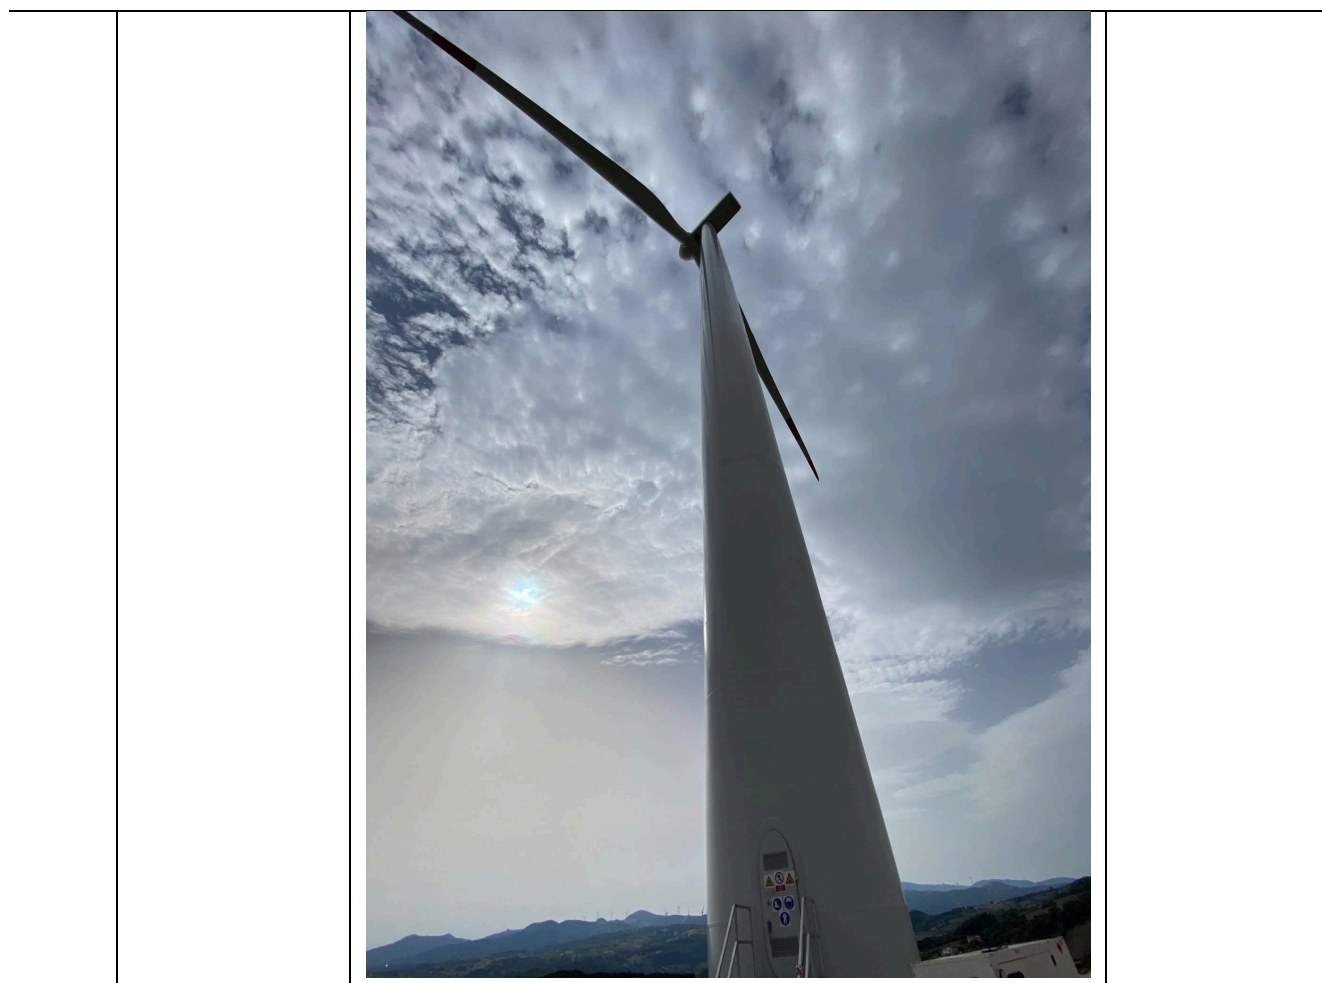
12	WTG04		
12.1	Crane platform	Works completed, restoration works to be done after the WTG erection completion	No relevant defect raised during the inspection
12.2	Foundation	Foundation piles successfully tested and backfill completed	No relevant defect raised during the inspection
12.3	WTG	Erection successfully performed	No relevant defect raised during the inspection

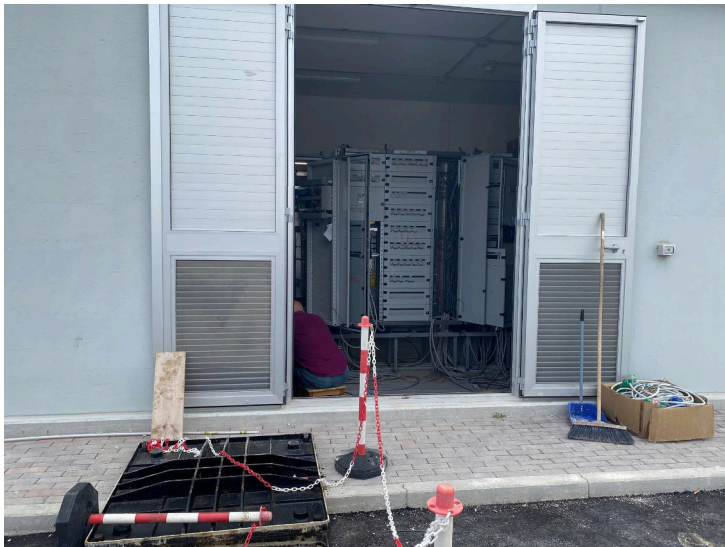
15	Electrical Substation		
15.1	Civil works	Minor civil works completed	No relevant defect raised during the inspection
15.2	Cabins	<p>Switchgears wiring ongoing</p>

No relevant defect raised during the inspection
15.3	MV/HV Transformer	<p>Minor works in order to allowed Terna substation energizzazione</p>

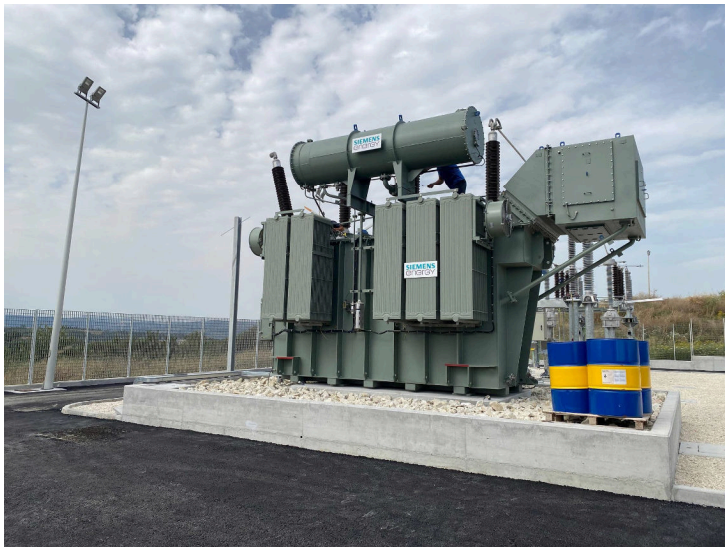
No relevant defect raised during the inspection
