Wind Farm CASALDUNI

Inspector	Ing. Matteo Canevello
Attendants to the inspection	Ing. Raffaele Petrucciolo
Inspection Date	15.06.2023

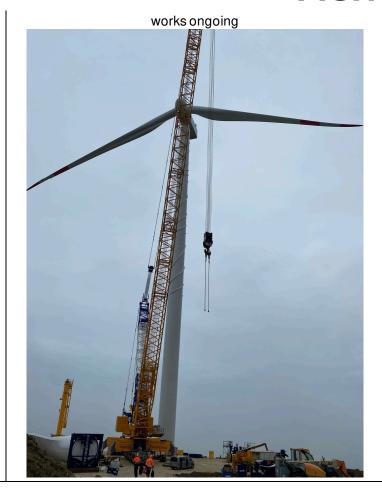
12	WTG04		
12.1	Crane platform	Works completed, restoration works to be done after the WTG erection completion	No relevant defect raised during the inspection
12.2	Foundation	Foundation piles successfully tested and backfill completed	No relevant defect raised during the inspection
12.3	WTG	works ongoing

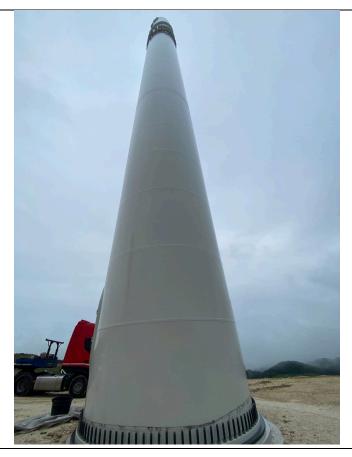
13	WTG05		
13.1	Crane platform	Works completed, restoration works to be done after the WTG erection completion	No relevant defect raised during the inspection
13.2	Foundation	Foundation successfully tested and backfill completed	No relevant defect raised during the inspection
13.3	WTG	Erection successfully performed
