Wind Farm CASALDUNI

Inspector	Ing. Giacomo Rosi
Attendants to the inspection	Ing. Raffaele Petricciuolo
Inspection Date	26.10.2023

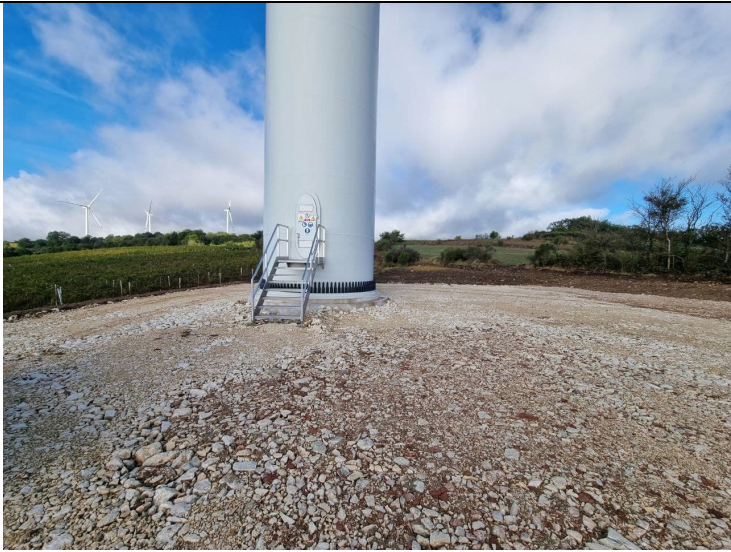
6	WTG10		
6.1	Crane platform

<p>Works completed; restoration works started</p>	No relevant defect raised during the inspection
6.2	Foundation	Foundation piles successfully tested and backfill completed	No relevant defect raised during the inspection
6.3	WTG	Erection successfully performed	No relevant defect raised during the inspection
7	WTG11		
7.1	Crane platform	Works completed; restoration works to be done after the WTG erection completion	No relevant defect raised during the inspection
7.2	Foundation	Foundation piles successfully tested and backfill completed	No relevant defect raised during the inspection
7.3	WTG	Erection successfully performed	No relevant defect raised during the inspection

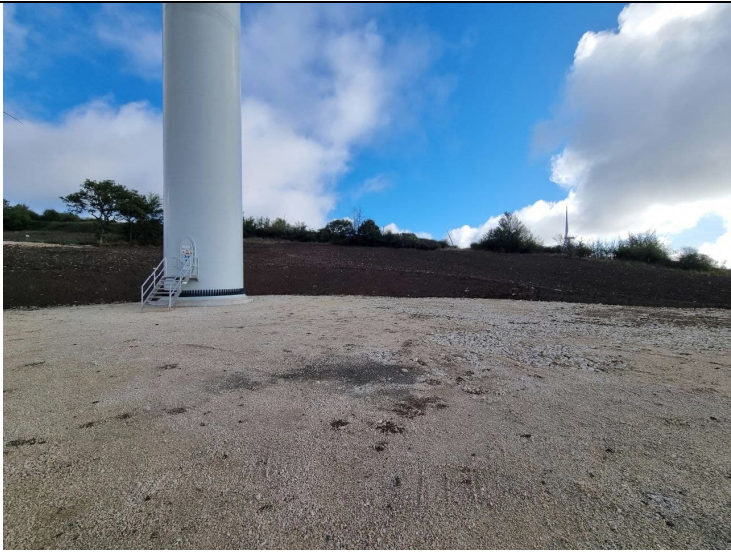
8	WTG13		
8.1	Crane platform

<p>Restoration works completed</p>	No relevant defect raised during the inspection
8.2	Foundation	Foundation piles successfully tested and backfill completed	No relevant defect raised during the inspection
8.3	WTG	Erection successfully performed	No relevant defect raised during the inspection

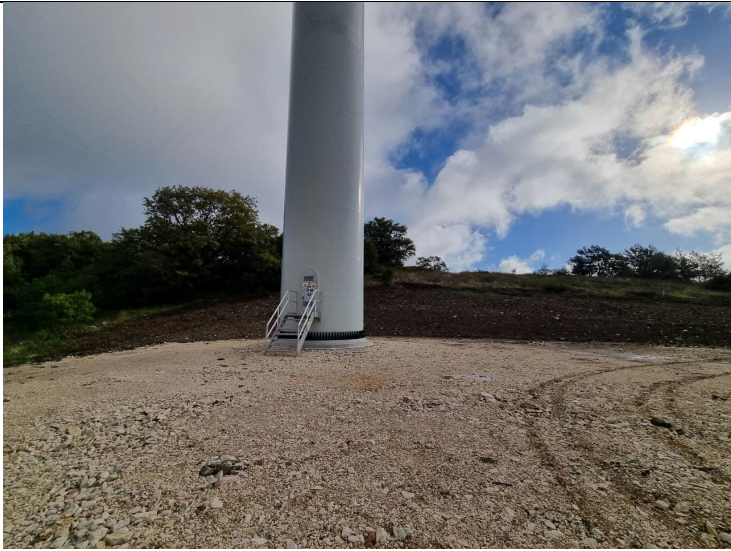
9	WTG14		
9.1	Crane platform

<p>Restoration works completed</p>	No relevant defect raised during the inspection
9.2	Foundation	Foundation piles successfully tested and backfill completed	No relevant defect raised

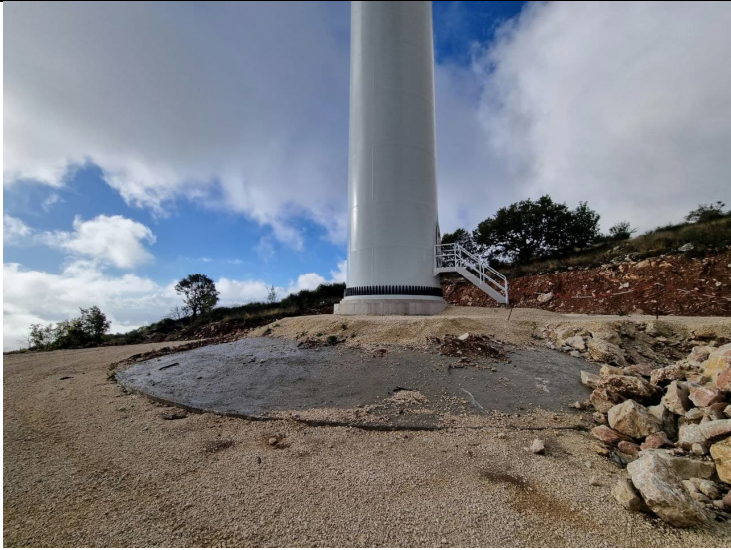
during the inspection
9.3	WTG	Erection successfully performed	No relevant defect raised during the inspection
10	WTG18		
10.1	Crane platform

<p>Works completed; restoration works started</p>	No relevant defect raised during the inspection
10.2	Foundation	Foundation successfully tested and backfill completed	No relevant defect raised during the inspection
10.3	WTG	Erection successfully performed	No relevant defect raised during the inspection
11	WTG3		
11.1	Crane platform	Works completed; restoration works to be done after the WTG erection completion	No relevant defect raised during the inspection
11.2	Foundation	Foundation piles successfully tested and backfill completed	No relevant defect raised during the inspection
11.3	WTG	Erection successfully performed	No relevant defect raised

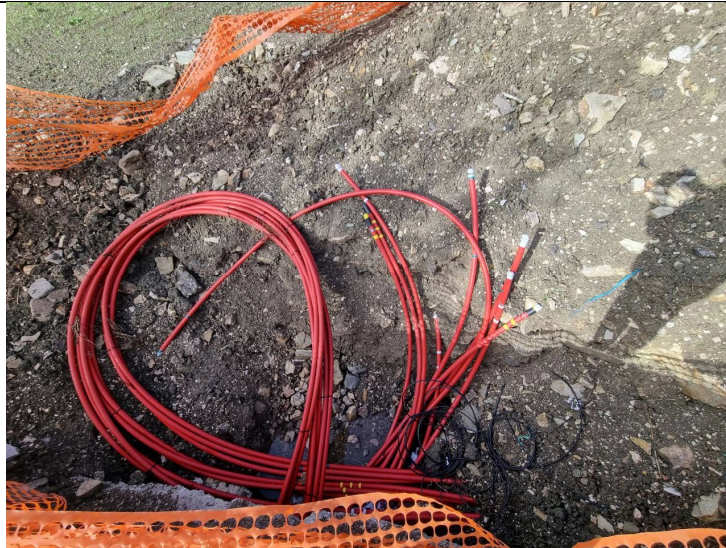
MV line joints

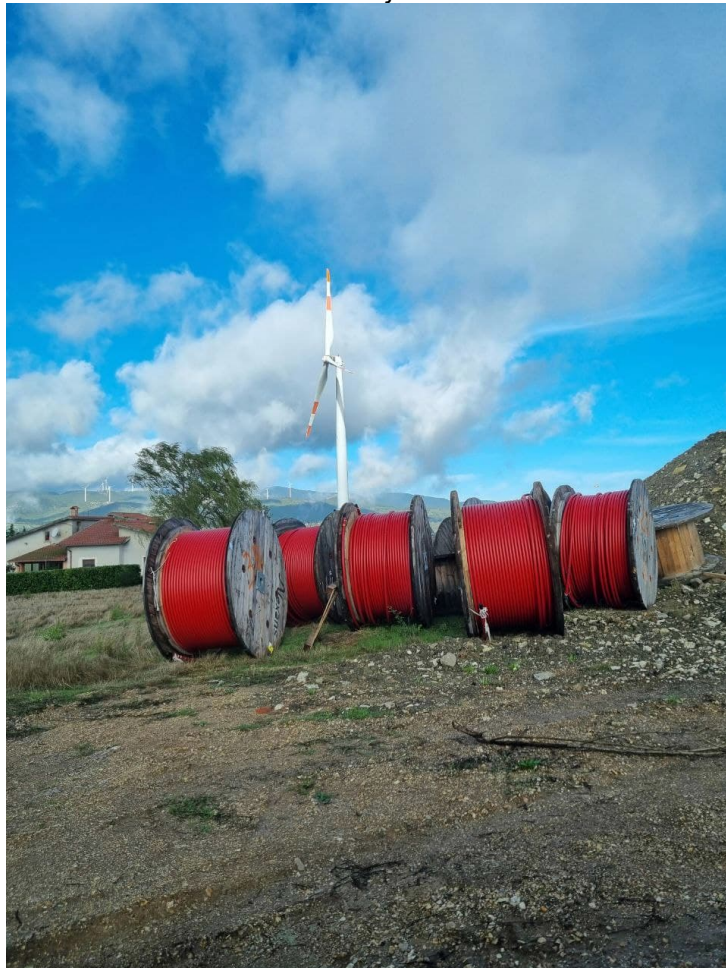
Cable coils stored near the substation for the completion of the remaining 700 meters of the MV cable line of the 3 turbines plot.

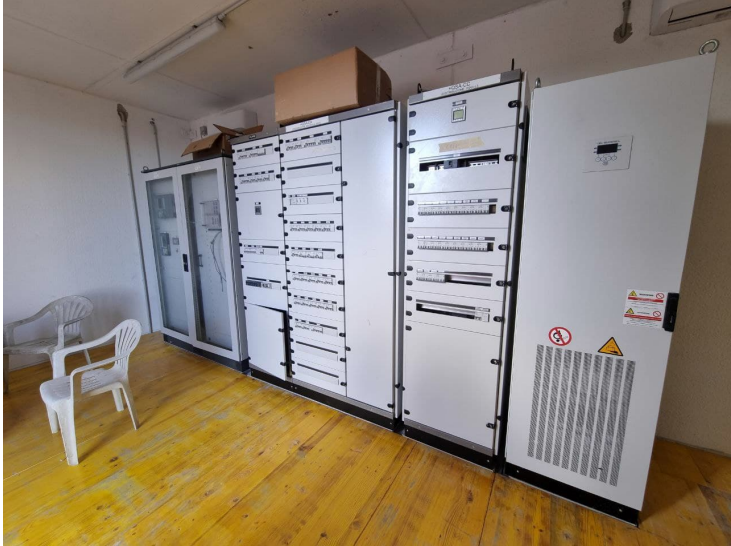
15	Electrical Substation		
15.1	Civil works	Minor civil works completed. Almost completed the restoration of access roads for blades transport	No relevant defect raised during the inspection
15.2	Cabins	Completion of the floor ongoing

No relevant defect raised during the inspection
15.3	MV/HV Transformer	Completion of the substation, permanent gate installation ongoing

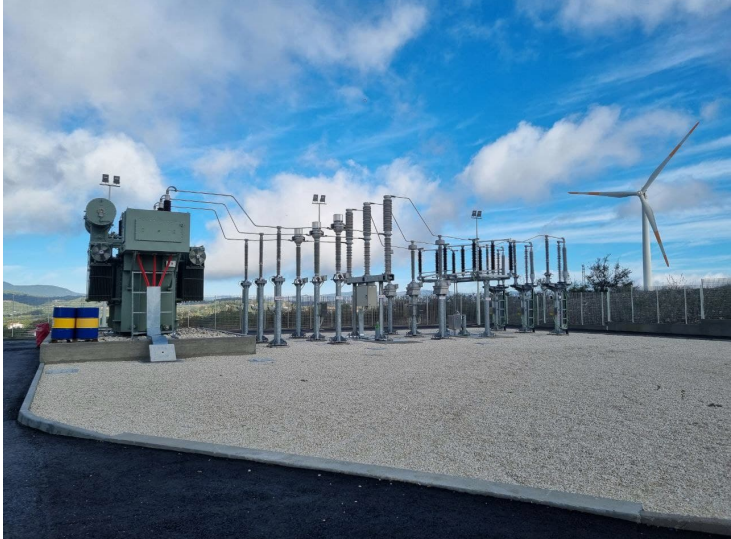
No relevant defect raised during the inspection
