Wind Farm CASALDUNI

Inspector	Ing. Matteo Canevello
Attendants to the inspection	Ing. Raffaele Petrucciolo
Inspection Date	07.11.22

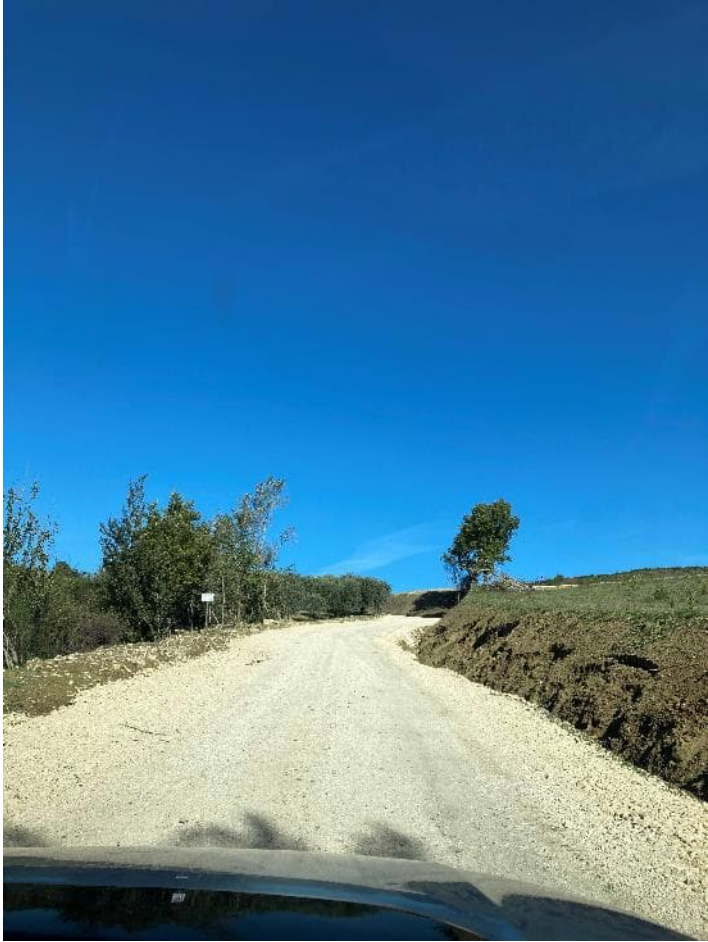
3	Access to the site		
3.1	Roads

<p>No relevant defect raised during the inspection</p>

Roads in good condition

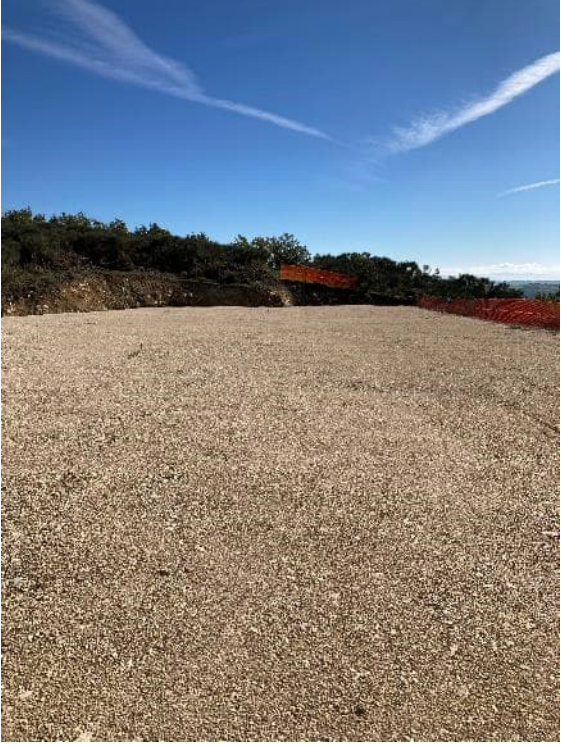
4	WTG08		
4.1	Crane platform

<p data-bbox="826 1048 1038 1077">Works completed</p>	No relevant defect raised during the inspection
4.2	Foundation

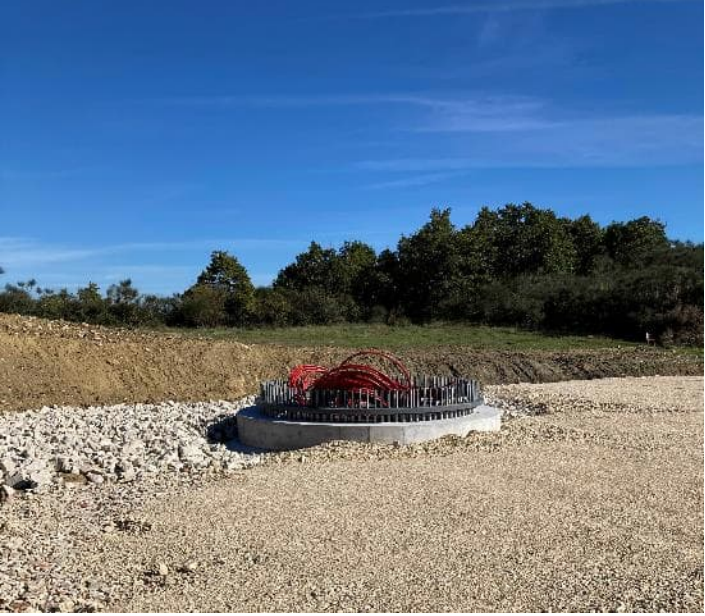
<p data-bbox="579 1709 1286 1738">Foundation piles successfully tested and backfill completed</p>	No relevant defect raised during the inspection
4.3	WTG	Yet to be erected

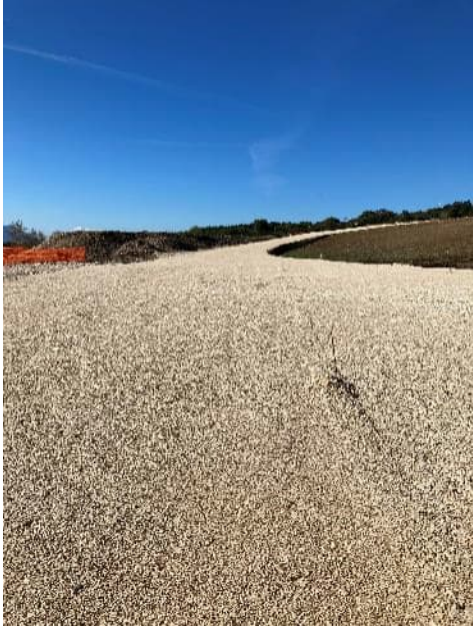
5	WTG09	
5.1	Crane platform

<p>Works completed</p>
5.2	Foundation

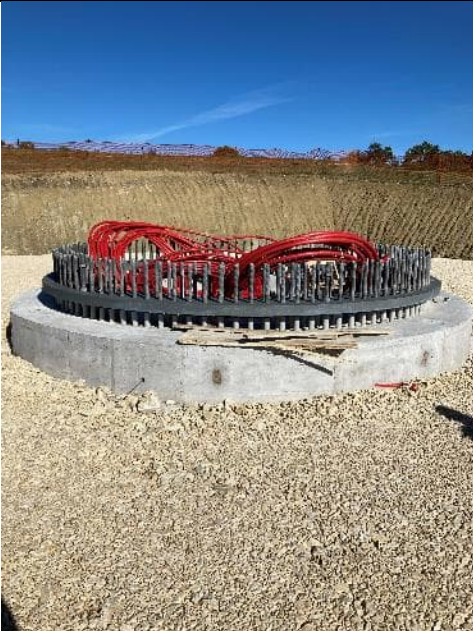
<p>Foundation piles successfully tested and backfill completed</p>
5.3	WTG	Yet to be erected

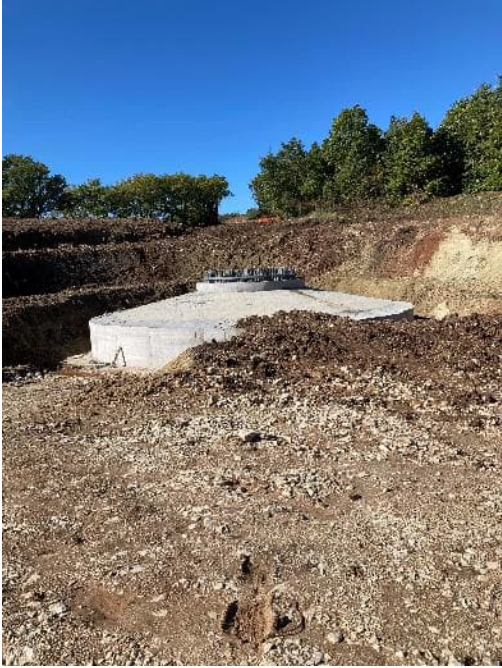
7.2	Foundation

<p data-bbox="807 869 1075 902">backfill works ongoing</p>	No relevant defect raised during the inspection
7.3	WTG	Yet to be erected	
8	WTG13		
8.1	Crane platform	No relevant defect raised during the inspection	
8.2	Foundation

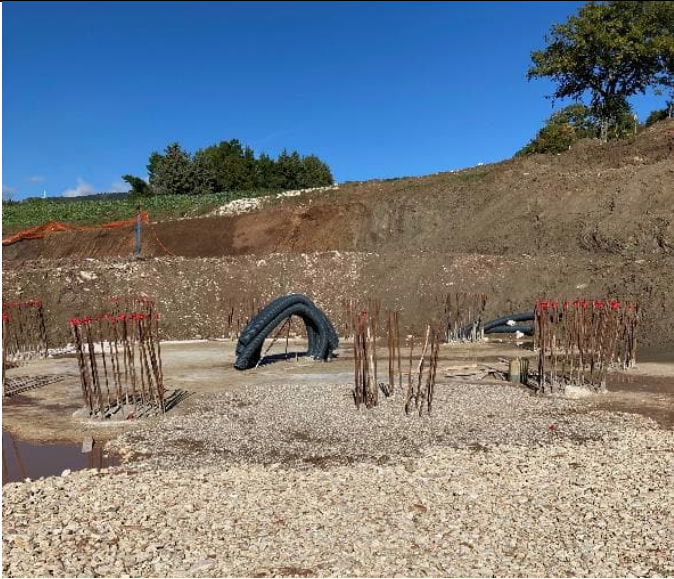
<p data-bbox="767 1832 1115 1865">Foundation piles to be tested</p>	No relevant defect raised during the inspection
8.3	WTG	Yet to be erected

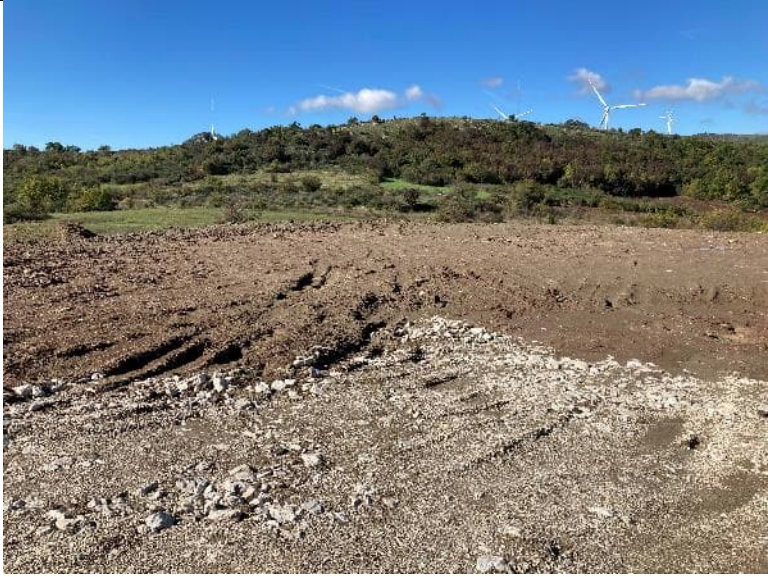
9	WTG14		
9.1	Crane platform

<p style="text-align: center;">preliminary works ongoing</p>	No relevant defect raised during the inspection
9.2	Foundation

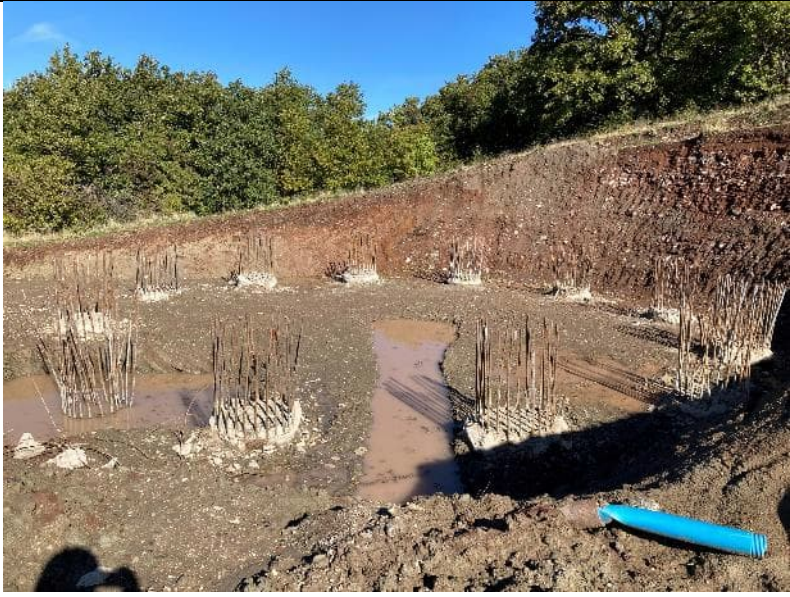
<p style="text-align: center;">Foundation piles to be tested</p>	No relevant defect raised during the inspection
9.3	WTG	Yet to be erected

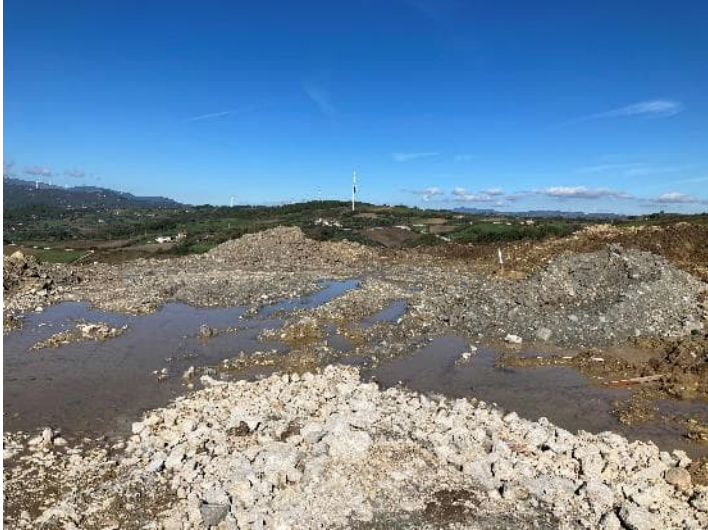
11	WTG3		
11.1	Crane platform

<p>Preliminary works ongoing</p>	No relevant defect raised during the inspection
11.2	Foundation

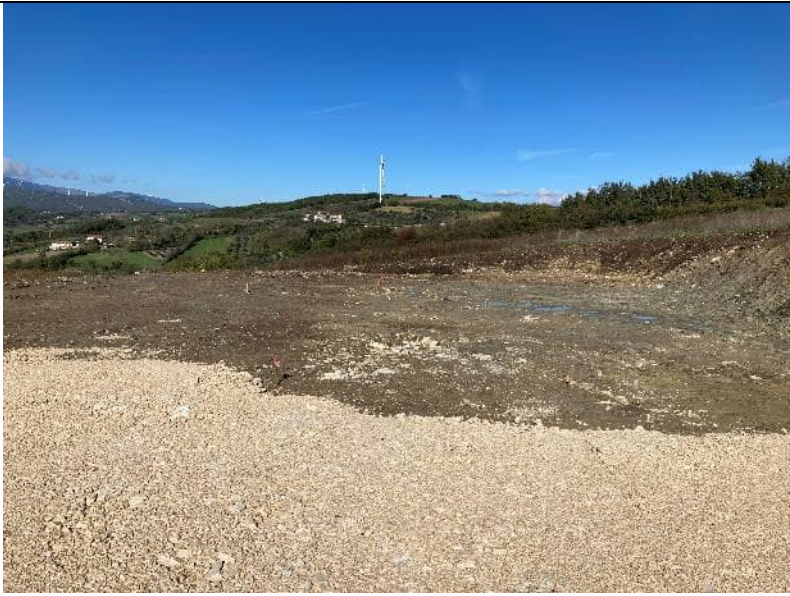
<p>Preliminary works ongoing</p>	No relevant defect raised during the inspection
12.2	Foundation		
12.3	WTG	Yet to be erected	
13	WTG05		
13.1	Crane platform

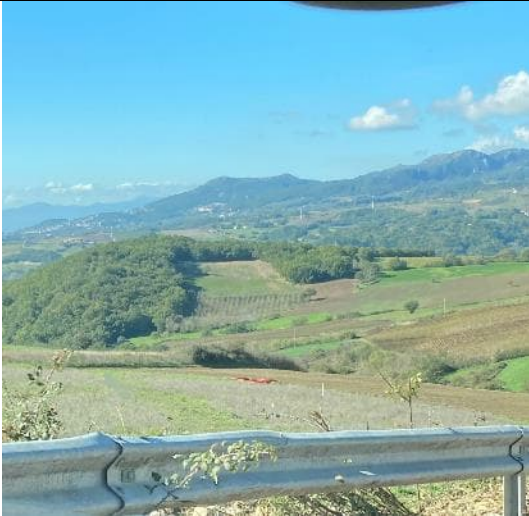
<p>works to start in the following weeks</p>	
13.2	Foundation		
13.3	WTG	Yet to be erected

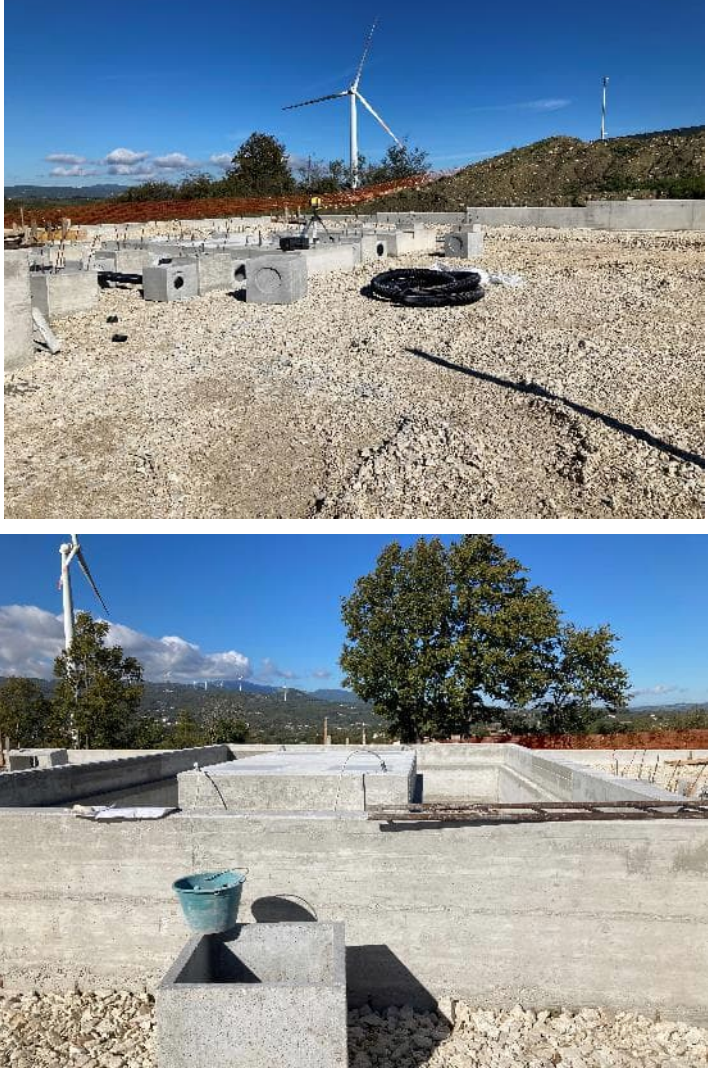
15.2	Civil works

<p data-bbox="842 1279 1038 1312">Trafo AV/MV pit</p>	No relevant defect raised during the inspection
------	-------------	---	---
