Wind Farm CASALDUNI

| Inspector | ING. FRANCESCO SPANO' |
|---|--|
| Inspection Date | 20.06.22 |

Site Visit Report Wind Farm CASALDUNI

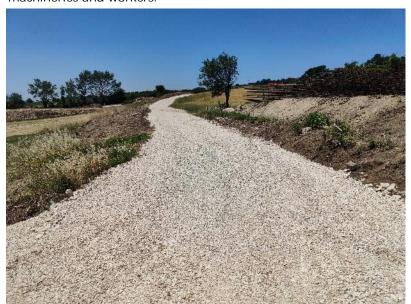
4.1 Roads

The actual status of internal roads allows arrival on site of materials, machineries and workers.

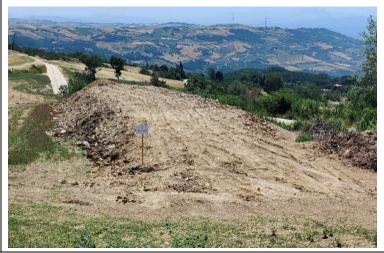
5.4 Land storage

The land storage from excavation is compliant with the provision of the Reuse Plan (Ref. Doc. 239EEOLIM000CANRE001A). The provisional deposits are identified as per design. No information notice with details of the Plan was affixed at site.

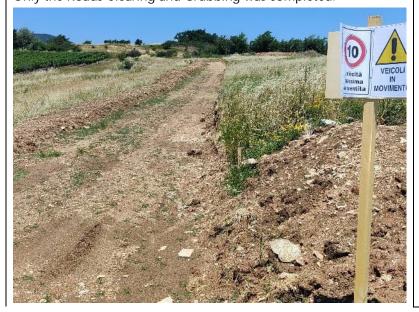
6.1 Roads

Only the Roads Clearing and Grubbing was completed.

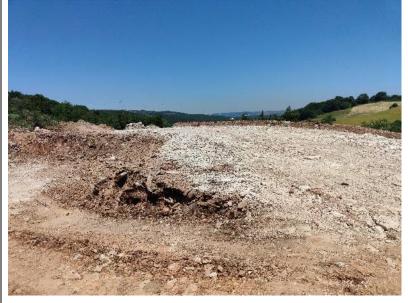
The embankment of the platform appears very high. Some correction will be necessary to avoid potential sliding and water erosion.

| No. | Category | Description of Defect | Defect cat. |
|---|---|---|---|
| M-4 | Platform | Some correction will be necessary to avoid potential sliding or water erosion | Minor |

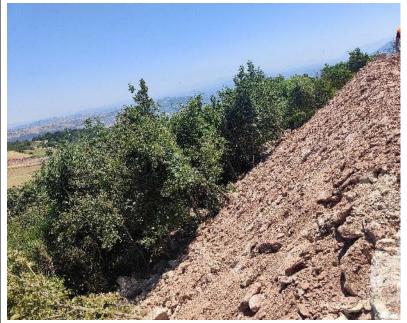
10.3

The Civil Subcontractor Corbo is carrying out the excavation of foundation. The activity is going to complete with some difficult, caused by the presence of weathered rock,

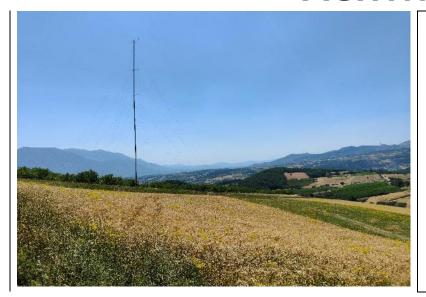
| 11 | WTG03-04-05 | | |
|---|---|--|---|
| 11.1 | Roads, Platform and Foundation | No construction activity was yet started in this area. | OK |
