Wind Farm CASALDUNI

| Inspector | ING. FRANCESCO SPANO' |
|---|--|
| Inspection Date | 20.06.22 |

Site Visit Report Wind Farm CASALDUNI

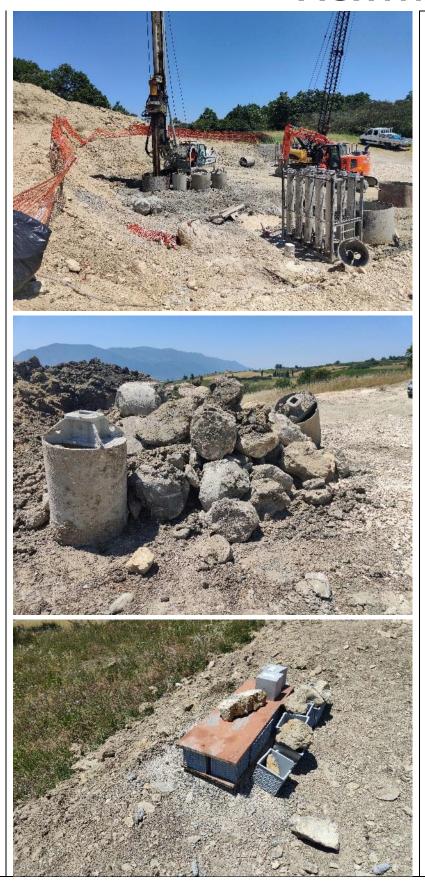
5

| 5 | WTG09 | | |
|---|---|--|---|
| 5.3 | Foundation | The excavation of foundation was complete, ready for the piles perforation. | OK |
